# SERVICE BULLETIN

### 30S-1 RF LINEAR AMPLIFIER

#### SERVICE BULLETIN NO 2

#### PREVENT INTERMITTENT DROPOUT OF PLATE OVERLOAD RELAY

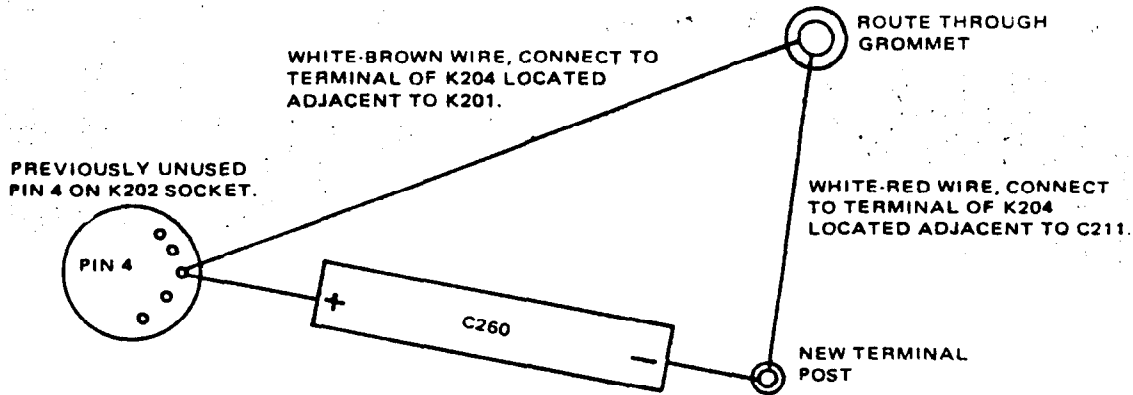
**30S-1 Relay Shelf, Underside, Modification Instructions**

Some 30S-1 operators experience occasional dropout of plate overload relay K204, caused by short duration high plate currents. These currents sometimes occur after application of signal but before the exciter output is reduced by the alc circuits. A 2000- $\mu$ F, 6-volt dc capacitor installed across the energizing coil of the relay presents a low-impedance path to the audio envelope currents, but continues to provide dc overload protection. The instantaneous currents are not harmful to the 6CX1000A tube because of conservative tube operation.

3. Install 2000- $\mu$ F capacitor C260 (183-1311-000) and approximate 10-inch lengths of white-brown (439-7302-000) and white-red (439-7303-000) wires as shown in the illustration.
